SURVEY FOR
ASBESTOS-CONTAINING MATERIALS FOR
SKILLS 1ST LTD
AT 2 CEDAR CHASE SL6 0EU

Reference Number : 16910
Report Issue : Re-Issue 1

Type of Survey: Refurbishment

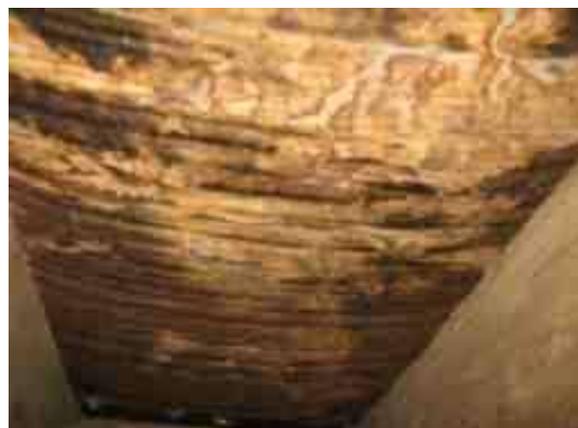
Product : Paper
Damage/Deterioration : Low Damage
Surface Treatment : Unsealed Paper

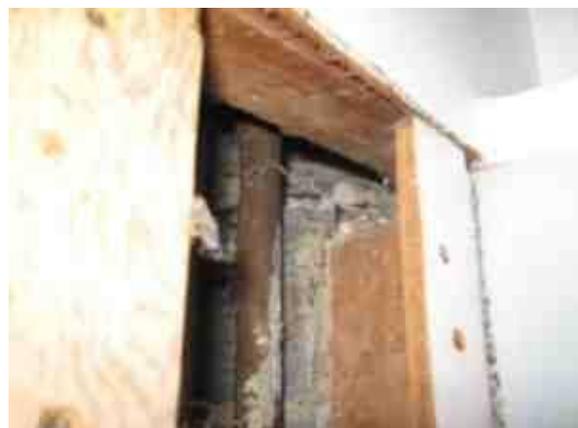
Product : Cement
Damage/Deterioration : Low Damage
Surface Treatment : Unsealed Cement

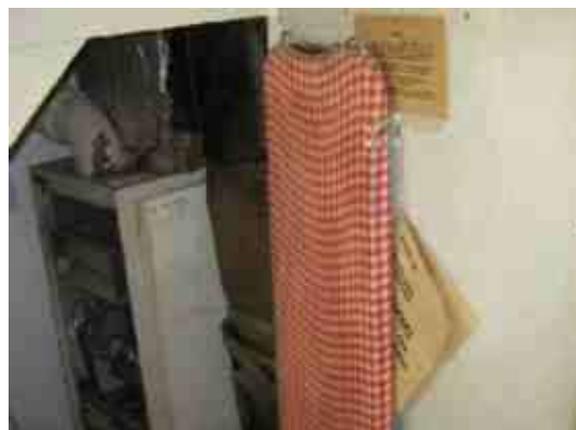
A sample was taken of the insulating board lining to the underside of the stairs (ref. sample no. 16910-007) and was found to contain amosite (brown asbestos) and chrysotile upon analysis. The board was unsealed.

Product : Insulating Board
Damage/Deterioration : Low Damage
Surface Treatment : Unsealed Insulating Board

The asbestos insulating board to room G.01 is a licensed asbestos product and its removal will require the services of a licensed asbestos contractor.

Remove under controlled conditions

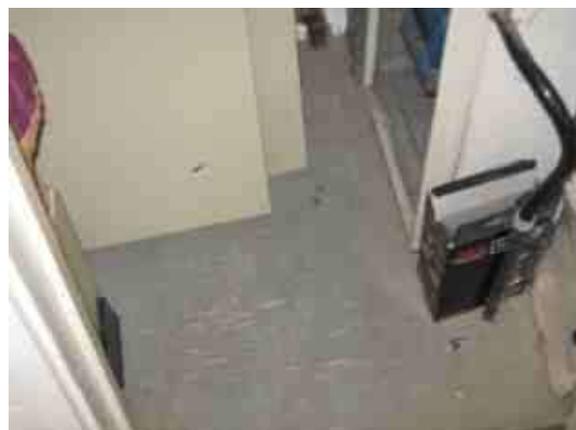
Product : Vinyl
Damage/Deterioration : Low Damage
Surface Treatment : Composites

All areas beneath carpet, only exposed in understairs cupboard. No photo

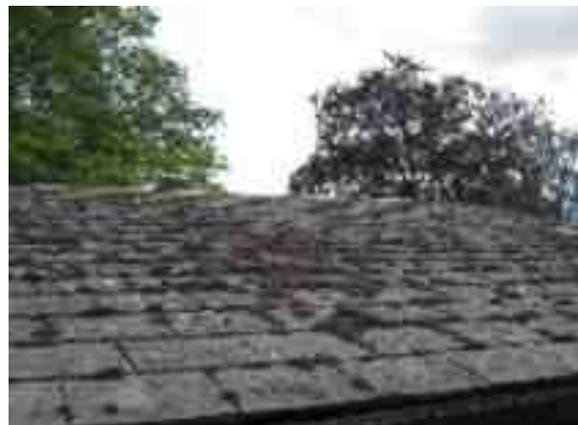
Description : Replacement tiles

Product : Cement
Damage/Deterioration : Low Damage
Surface Treatment : Unsealed Cement

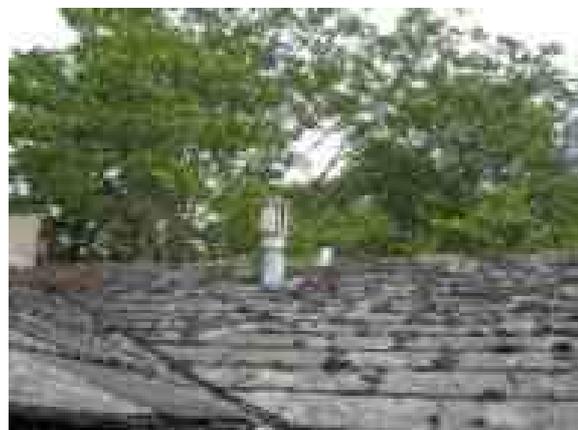
A sample was taken of the old roofing tiles to the roof (ref. sample no. 16910-015) and was found to contain amosite and chrysotile upon analysis. The slates showed medium levels of damage.

Product : Cement
Damage/Deterioration : Medium Damage
Surface Treatment : Unsealed Cement

It is recommended that the ACMs are removed prior to refurbishment. See general recommendations below.

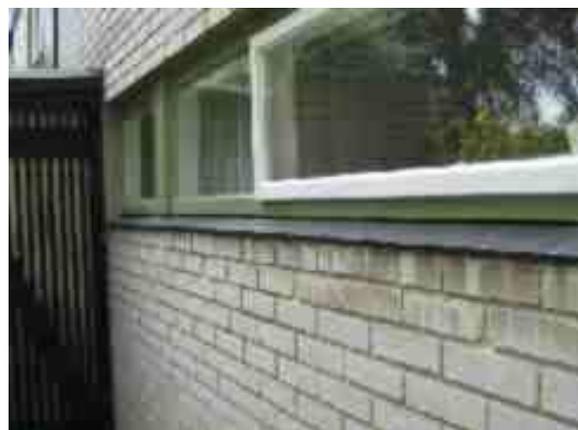
Product : Cement
Damage/Deterioration : Good Condition
Surface Treatment : Encapsulated Cement
