SURVEY FOR
ASBESTOS-CONTAINING MATERIALS FOR
SKILLS 1ST LTD
AT 2 CEDAR CHASE SL6 0EU

Reference Number : 16910
Report Issue : Re-Issue 1

Type of Survey: Refurbishment

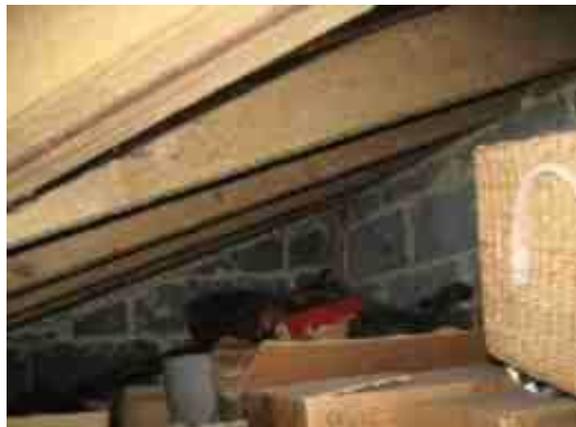
Foam and MMMF insulation to pipework., Timber rafters and joists (no insulation between). Plastic water tank. Plasterboard infill panels. No photo

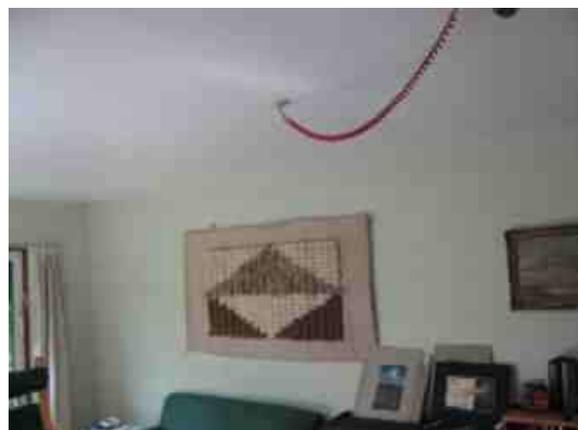
Plaster skimmed solid and plasterboard walls, plaster skimmed plasterboard ceilings. Timber window frames. Fitted carpets, floor tiles beneath. Solid slab beneath times. No photo

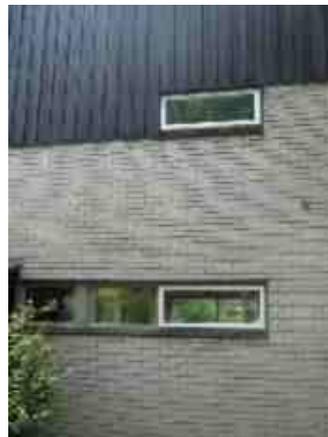
Brick and block main construction. Pitched tiled roof.,
Timber weatherboarding. Flat roof to porch with modern
covering. Glass roof to bin store. No photo
